Comprehensive Historic Preservation Plan

Nine Historic Buildings Owned by the City of Norwalk, Connecticut

The report that follows was prepared by John Milner Associates, Inc., between October 2009 and May 2010. It is a review of current conditions at nine historic buildings owned by the City of Norwalk, Connecticut, and a plan for their preservation and maintenance in upcoming years. The buildings are located in two locations: Mathews Park and Mill Hill, including two buildings along Smith Street, at the edge of Mill Hill.

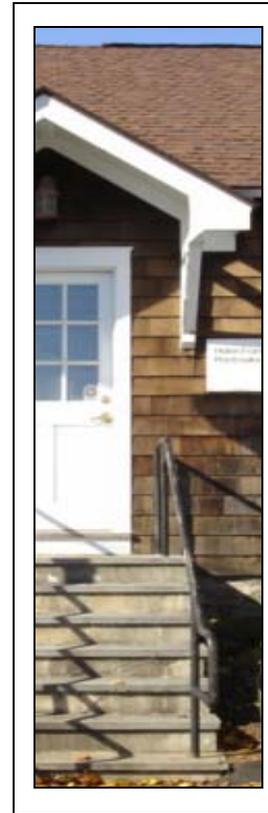
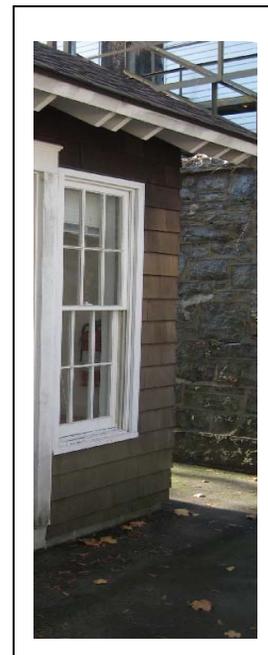
The Gardener's Cottage has similar problems on all sides, although the worse problems are on the north side of the house at the asphalt edge

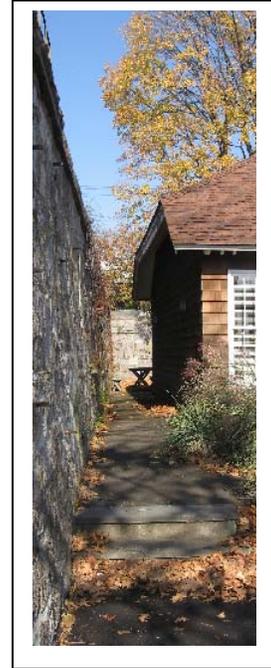
of the patio. On the west side of the house, the asphalt walkway fills the space between the house and the neighboring stone garden wall, which is approximately ten feet tall. The garden wall was suffering from severely deteriorated pointing when the project (for preparing this report) began, and it appeared to be in danger of falling on the Gardener's Cottage. It has since been repaired and repointed. However, the constrained configuration of the asphalt, with the slab-on-grade construction to one side and the garden wall on the other, is likely to cause problems in the future because it leaves little room for the natural movement of materials in seasonal expansion and contraction, as well as normal settling. It is possible that the wall could become destabilized at a future date if the surrounding soils move causing the building, the walkway, or the wall to shift toward one another. On the south side of the building, the asphalt serves as an accessibility ramp. While this is a good thing, it also results in more hard surfaced materials at the edge of the building. The ramp encircles an open planting area that contains some shrubs in addition to tall ornamental grasses and flowers in the warmer seasons. As attractive as they are, the planting may be further retaining the moisture and keeping the building in the shade deterring natural evaporation from rain water.

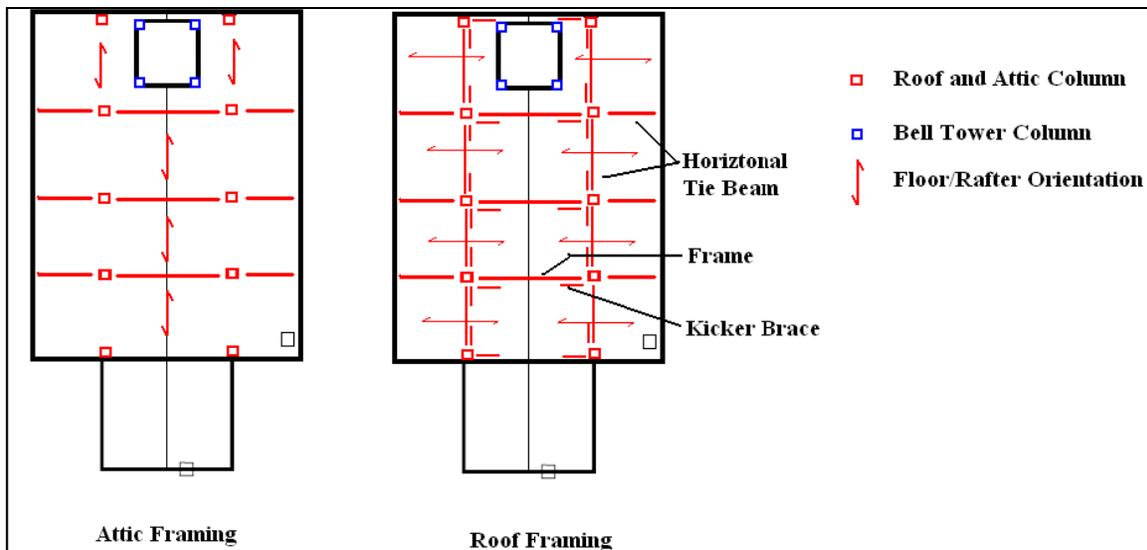
Town House Attic and Roof Framing

RSA viewed the attic space as well as the bell tower framing to gain a sense of how the existing structure is laid out and is supporting the roof and bell tower. The Town House has brick masonry bearing walls at the perimeter with six interior wood columns, plus two wood columns at each end of the building (plan diagram below). The columns extend from the first floor up into the attic space to participate in frames that support the roof. The frames are tied to the exterior masonry walls with horizontal wood beams that are mortised into the column at one end and the top plate at the top of the masonry wall at the other end (all within the attic). The frames are also tied to one another with horizontal beams running between columns from the front of the building to the back of the building. Kicker braces extend from each column in two directions, parallel to the length of the building between the column and the beams that tie the frames together, and perpendicular to the length of the building between the column and the horizontal member of the frame.

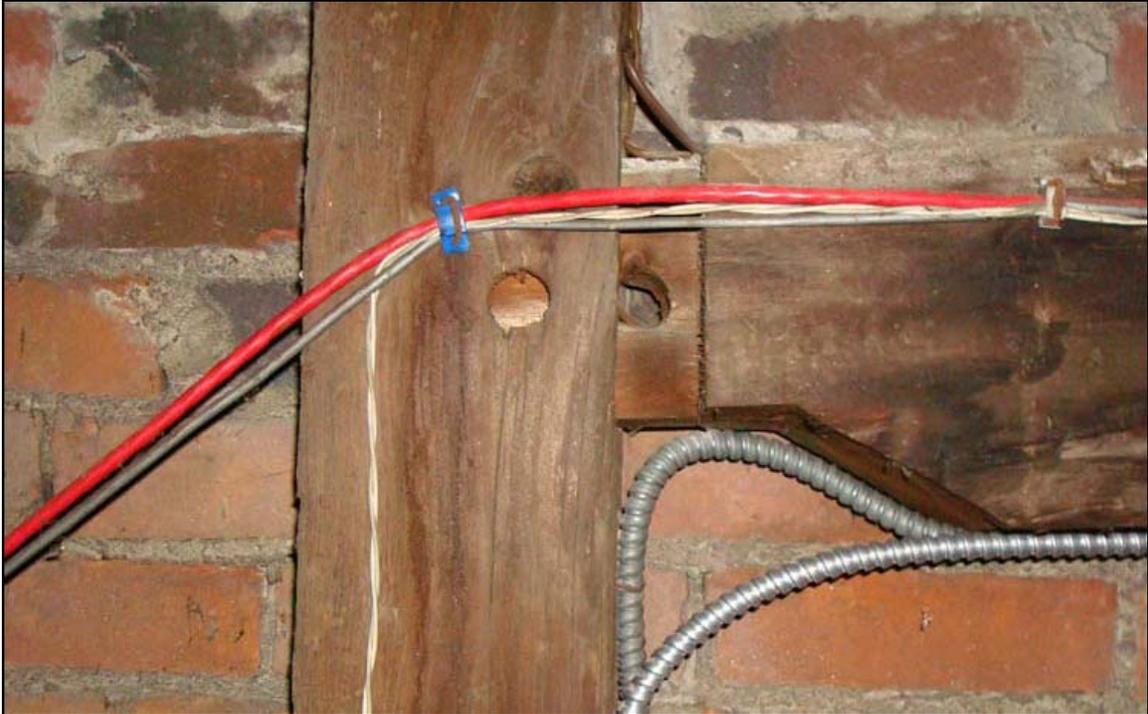
The cracking and joint movement prompts RSA to suspect possible movement in the eastern perimeter wall. We would suggest a plumb survey of the eastern wall to see if there is displacement along the length and height of the wall.

Joint displacement, tie beam to column connection

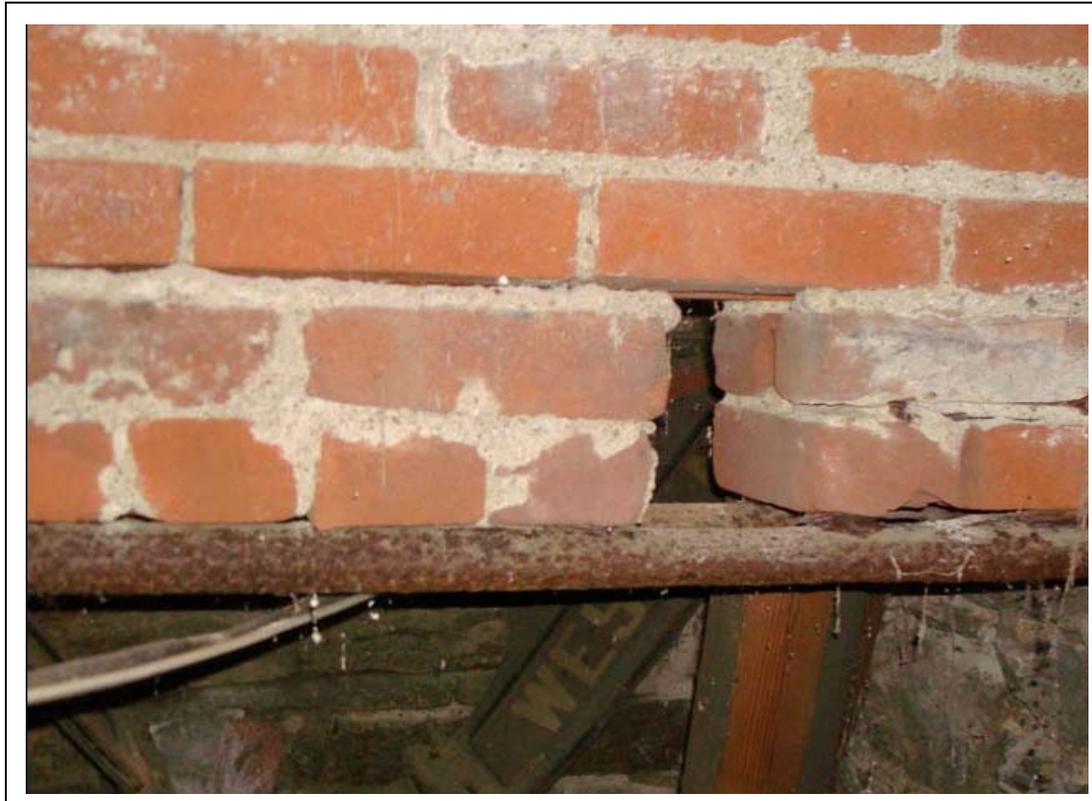
Jail House basement, corroding steel supporting masonry

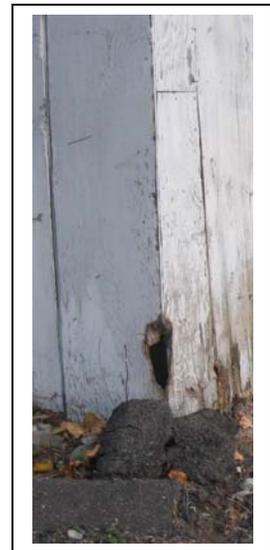
Infiltration of moisture from the bottom of the building and at exposed horizontal surfaces, such as the wood deck, may have contributed to the deterioration of the barn. The building is in poor, even precarious condition, but the structure has been reinforced by a steel I-beam and round steel columns that were added at the center of the interior. The I-beam and columns support the original summer beam on which the second story floor boards rest. In length, each of the joists is only a little more than half the depth of the building. The joists are lapped over the summer beam, which runs from side to side below the ridge of the roof. The summer beam was originally supported on wood columns, as evidenced by ghosting in the paint at the bottom surface of the beam. The original columns were apparently removed, or replaced by steel, in order to reconfigure the barn as a three-vehicle garage when the center garage door was added. It is also possible that the replacement was because they had rotted or failed structurally.

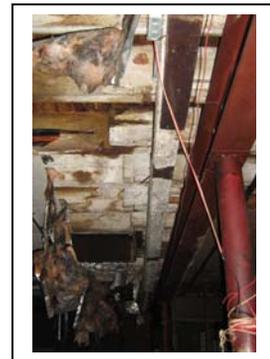
The back slope of the roof is one large surface draining without a gutter into the space between the building and the retaining wall. The space has piles of leaves and debris in it which are retaining moisture. The inner side of the same wall was inaccessible during the team’s field visit because of the amount of storage in the building and because of the falling layers of remodeling materials generally just behind the stored items. However, it appears that there was plenty of material on the inside of the rear wall to retain the moisture that is likely to come in as a
