Comprehensive Historic Preservation Plan

Nine Historic Buildings Owned by the City of Norwalk, Connecticut

The report that follows was prepared by John Milner Associates, Inc., between October 2009 and May 2010. It is a review of current conditions at nine historic buildings owned by the City of Norwalk, Connecticut, and a plan for their preservation and maintenance in upcoming years. The buildings are located in two locations: Mathews Park and Mill Hill, including two buildings along Smith Street, at the edge of Mill Hill.

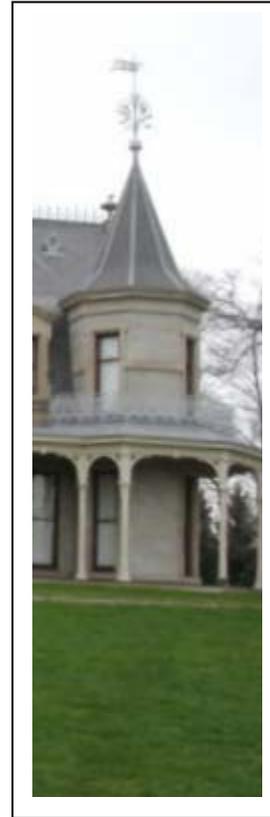
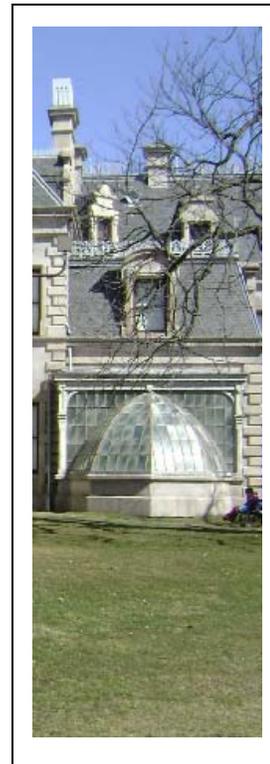
At the first floor, a conservatory protrudes from the southwest wall. It is a blended form in design, a porch-like enclosure with a modified quarter-sphere dome projecting from it. The dome has a low, semi-octagonal stone wall at its base. In the original design, the conservatory was clad in pressed glass tiles that have a chevron-like diamond pattern with fleur-de-lis motifs in royal blue at the center of some of the diamonds. The glass tiles have been replaced with a reproduction of the original design made of a synthetic material such as Plexiglas (almost all of the originals were retained and are stored in the building). The arrangement of the transparent tiles is lapped, like roof slates, and thus the dome was designed to be open and naturally self-ventilated rather than air-tight. At the point where the dome meets the rectangular framed section that

resembles a small porch, the vertical walls between the porch columns were also clad in the glass tiles in a frame work that is structured between the columns. The columns are detailed as porch posts. The conservatory floor is covered with tiles arranged in a pattern. The present tiles are reproduced encaustic Minton tiles, matching the original in design and material, that were replaced after a tree fell on the Conservatory and it was restored in the 1960s. Most of the original Minton tiles are in storage in the building.

In a recent re-roofing project, a problem developed at the valleys which contributed to deterioration of the porch posts. As a result of moisture accumulating from the roof design, mitered wood base trim, nailed on to the bottoms of the posts, deteriorated and broke off. The posts were repaired with new base trim, but this also rotted and broke off. The base pieces and some of the post bases were replaced again at the beginning of the present project with mahogany. It is possible that other problems were involved, such as moisture wicking up from below into the posts as a result of the design.

- Replace the framing system and transparent tiles at the conservatory with newly made reproductions of the original tiles.

- Check the air space between the veranda floor and grade several times each year to make certain that it is free of any accumulation of organic matter and any signs of pests.
- If base details of veranda columns continue to show signs of moisture, or if applied base trim will not remain fastened, additional work may be needed to separate the columns from moisture and to repair or replace rotted wood in the posts themselves. In that case, periodically check moisture content of the wood to ensure that it is below (and remains below) 20%. If rotted wood is found and moisture content is above 20%, wood will have to be replaced in part (dutchman repairs) or whole elements with water-resistant wood such as mahogany or cypress.

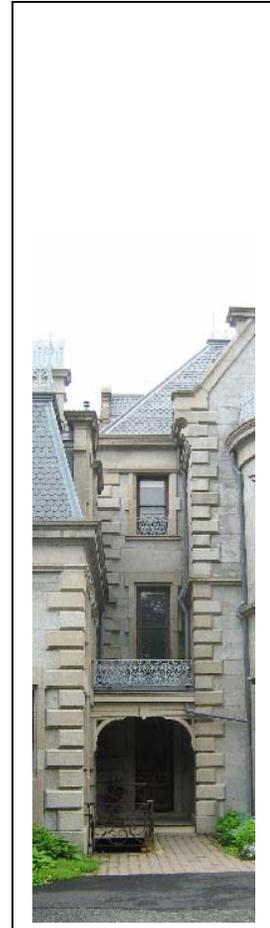
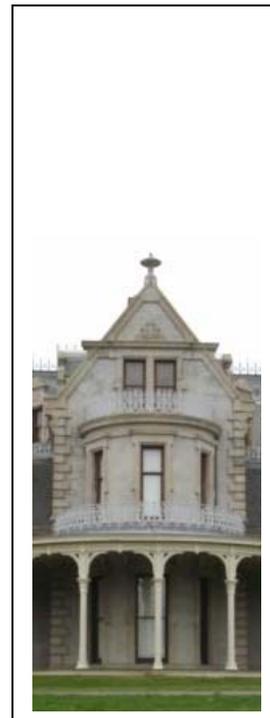
The Lockwood-Mathews Mansion benefits from being situated at a high point in the terrain and having grass at the edge of the building across about 80% of the perimeter. Although the rain leaders serving the roof drainage system have been hooked up by the City to the drainage system for Mathews Park, the site itself also drains well. It appears to have positive drainage in general away from the mansion, although this is less true on the north side where the asphalt pad of the parking area is roughly level with the grade at the house. Where pavement touches the

building, it consists almost entirely of square paver bricks that allow for some moisture to be absorbed naturally into the ground below without retaining an undue amount of it. The only area where the soil may be prone to retain moisture and cause damage is under the veranda. This is because the wooden sill plate of the veranda floor framing is very close to the ground. As long as a large amount of water is not flowing into this area, it should not be a problem by itself. However, if organic materials like leaves and soil pile up at the edge of the wood, filling the gap, the soil will retain a higher amount of moisture and the wood will be more likely to remain wet and will also be easier for pests, such as termites and rodents, to reach. (An effort has been made recently to remove a family of groundhogs that had taken up residence under the porch over a period of many years).

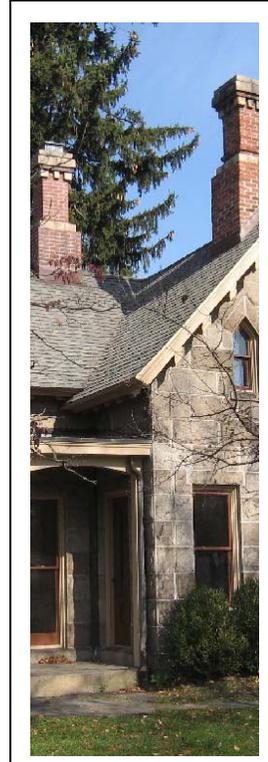
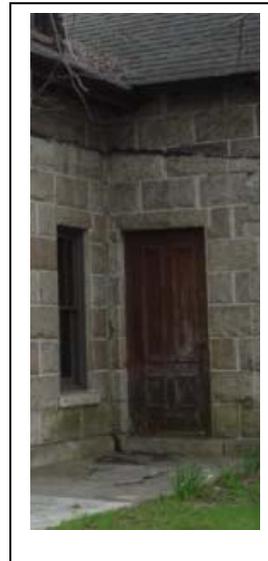
The two indentations facing west contained porches in the original design. The porch that remains in place, at the southwest corner of the house, carries about a fourth of the rain water effectively into at least one downspout (a second downspout is found at the inside corner of the porch, but it may not be functioning at present). The removal of the northwest porch resulted in the water from that quadrant of the roof falling directly onto the concrete slab that had served as the porch floor. Water hitting and splashing this slab has caused biological growth on the stone and decay in the bottom components of the wooden door that opens onto the former porch. In the original design, the porch probably had a wood floor, as found at the veranda of the mansion, since concrete was a rare material at the time. The north orientation of this area is also a contributing factor because the areas that are bombarded with the moisture are in shade much of the day, particularly in certain seasons of the year.

The concrete slabs may not be the original porch floor material. Modern concrete with a strength and exterior durability needed in a floor slab was not generally available by the 1860s, and it would be highly unusual to have used it in this application. It is more likely that the porches had wood floors that rotted and were replaced around 1890-1910. The concrete appears in historic photographs from that time period, and it is detailed in a way, with drafted lines in the surface and rounded edges that are consistent with concrete work from the early twentieth century.

- Incorporate the provision of an accessible entrance in the restoration of the northwest porch.
- Check chimney flue linings for water-tightness and check metals used around chimneys incompatible metals or for any signs of damage from galvanic action.

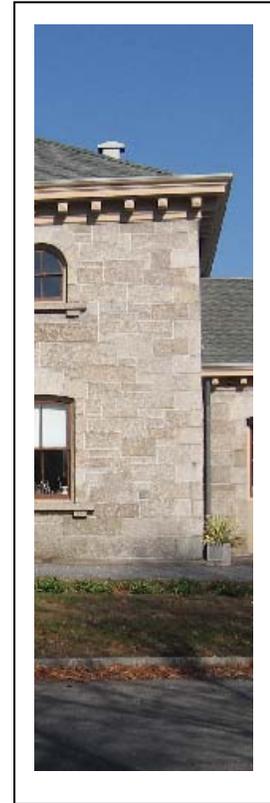
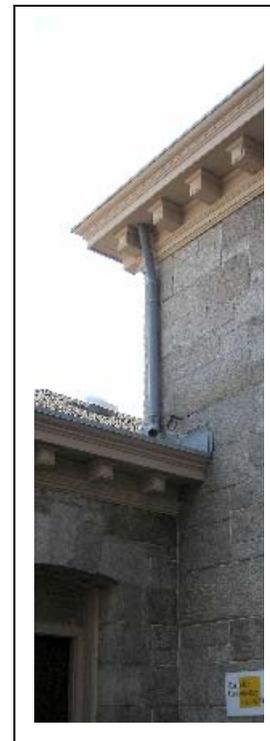
The Carriage House is designed as three pavilions, the center one being taller. The east pavilion was built as a stable and most of its windows are very small. The west pavilion was a garage for carriages, as evidenced by the three arched openings that have since been in-filled in its façade. The center pavilion is two stories and has wood floors in both stories, while the flanking wings have concrete floors presumably a replacement for earlier dirt floors in the original design.

The asphalt shingle roof was installed recently. A large level section at its center above the middle pavilion once had a belvedere that provided an additional way to ventilate the building. The belvedere was surrounded by a wood railing, or widow walk. The belvedere was removed about fifty years ago, and the flat-roofed area now has a membrane roof. There is a smaller flat-roofed area at the peak of the roof over the east wing of the building, the section of the building built as a stable. About half of the flat-roofed section in that location is covered by a piece of mechanical equipment. The roofs drain into built-in box gutters that are part of the building's cornice. Rain leaders at or near the four corners of the center pavilion empty directly onto the roofs of the lower pavilions almost immediately over the downspouts that serve the lower gutters. The rain leaders from the lower gutters lead directly down to the stone watertable where most of them empty onto grade with splash guards. In one or two instances, there is a boot for a connection to below-ground drainage, but in each of these cases, the rain leader merely discharges over the opening without connecting to it. The roof is penetrated in no fewer than 12 places by ventilation features of various kinds. This includes a brick chimney stack that appears to date from the original nineteenth century construction, one or two plumbing vents, and at least one large piece of mechanical equipment. It also includes four or five ventilation fans mounted to the roof surface. Additionally, a ventilation pipe taking combustion exhaust air away from the furnace passes through a pane of glass in a first story window, and there are other ventilation features in current or former first story door and window openings. The building is cooled in the summer by use of window air-conditioning units, one of which is permanently mounted in the transom area of an entrance door near the building's front.

The walls are designed with a cut-stone exterior layer of granite and a random-laid rubble inner layer. It is not known for certain if there is a ventilation cavity between the two layers, but it appears to be a likely possibility. At the watertable at the base of the walls, ventilation openings were left in the stone in at least eight locations. Six of these openings have been filled with concrete and one has been covered with a solid ferrous metal plate, leaving only one of them open, to the left of the building's main entrance in the middle pavilion. Photographs taken into this cavity show that the openings in the middle pavilion provided ventilation beneath the wood joists that support the floor. The joists are only a few inches above grade, and the ventilation may have been felt necessary because of that condition. The first floor has vertical bead-board on most of the wall surfaces, and it is clear that air from the ventilation openings flowed behind the boards. While that may have been a benefit when the building was not heated, the current occupants have experienced draftiness at these edge areas and have installed baseboard in an effort to limit the air-flow directly into the building. It is less clear whether or not there is a cavity between the two layers of stone, as there is at the Lockwood-Mathews Mansion and possibly also at the Gate Lodge. However, if there is, the ventilation openings may have been intended to ventilate the stone as well, as a means to control condensation, changes in humidity, and similar factors. Only four of the ventilation openings were at the perimeter of the center pavilion. At least four others ventilated the perimeter of the original dirt floor of the stable pavilion. When it was used as a stable, the openings at the perimeter of this wing may have also served to reduce odors from the animals and drain liquids from animal waste, as well as water from the periodic cleaning of the animals and stalls. A current staff member at the printmaking facility has suggested that the ventilation openings may not have been needed since the building ceased to serve as a stable. While it may be true in part that they were there due to animal odors and refuse, ventilation of the walls may have also been intended when the building was constructed, or even if not intended, it may have served important purposes in that regard. At least four of the openings appear to have been closed-in with concrete as part of the installation of the interior concrete slab floor. With the slab in place, it may be difficult and also possibly pointless to reopening these openings. However, it is the conclusion of this study that the openings leading to the cavity under the wood floor should be kept open, or reopened as the case may be. To keep animals out, screen or grates should be installed a half inch to an inch behind the face plane of the watertable.

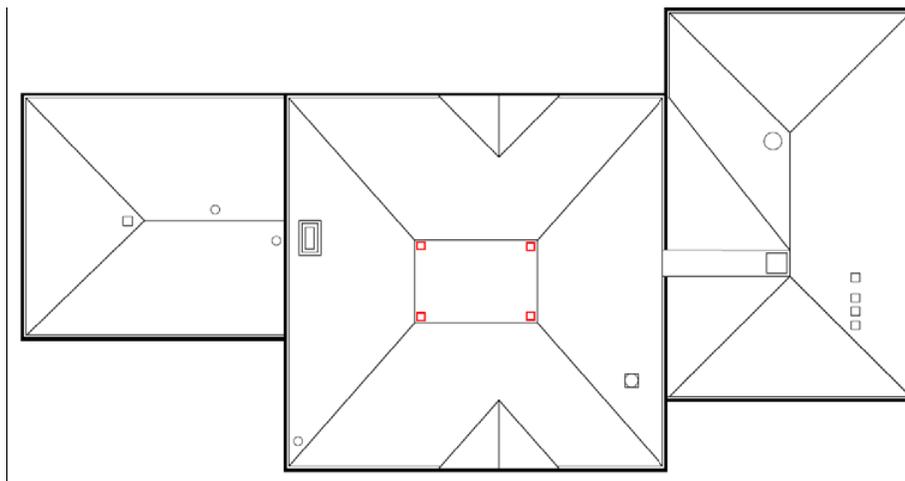
Figure 1: Carriage House Plan

The roof structure of the Carriage House has been altered over the lifetime of the building. It is our understanding that, in the 1970’s, four interior wood columns were removed from the roof down to the first floor. The wood columns were later replaced, but only from the first floor up to the underside of the first floor ceiling. This was said to have been done “to support heavy printing presses” that were used in the attic space above. It appears that the columns installed at the first floor were installed in a green state and have since dried and have undergone some warping.

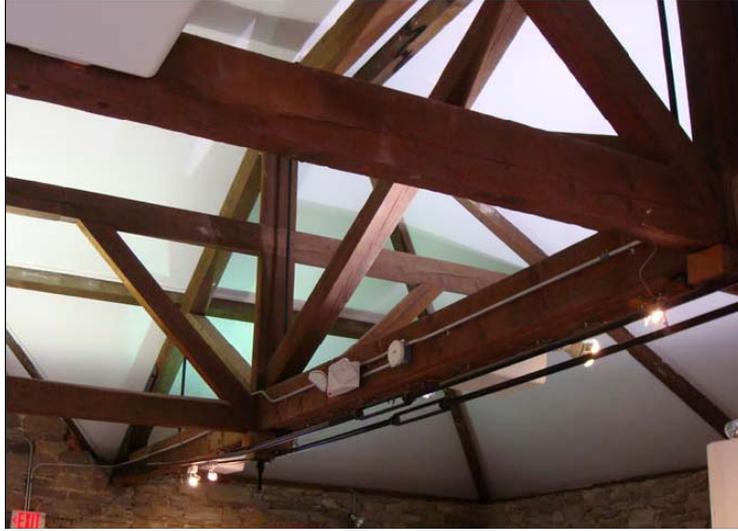
Picture 1: Partial view of Carriage House roof “truss”

In altering the structure, it appears that the designers of the 1970’s modification attempted to create a “truss” using the existing framing and adding steel elements. Steel rods (both horizontal and vertical) were added to the existing wood framing, presumably to carry the tension loads entirely or reinforce the existing wood members that were in tension within the newly created “truss.”

Although the original framework of the roof structure may have resembled a truss configuration, RSA believes that the original roof framing was intended to be a post and beam structure with diagonals to provide stiffness to support the belvedere above. It appears that the present roof framing is a result of an attempt to convert the original structural system into a truss system. It is unknown if this “conversion” of the structural system was done under the design and supervision of a licensed professional engineer. If it was, it would be very helpful to the review of this work if any drawings and calculations could be found and copied for our use. Below is the plan of the Carriage House with the approximate location of the first floor interior columns indicated in red, as well as a photo of the “trusses” supporting the roof.

There are a number of signs that indicate to us that the roof structure of the Carriage House was not intended to perform as a truss system. Beyond the fact that originally there were columns that would not have been required if there was a truss system in place, it appears the bottom chord of the truss was not designed to be a tension member. The bottom chord (i.e., the bottom horizontal line or member of the truss) is not a continuous member, and it would be uncommon to find a discontinuous member designed as a tension member.

These issues with the roof framing system present themselves without the presence of the belvedere load, in and of itself, or the additional wind load the structure will see with the cupola added. Before considering the additional loading associated with the cupola addition, we would recommend further study to see how the current system is performing and determine its structural capacity. The study would include measurements of the existing structural members and their spatial relationship to one another followed by a structural analysis of the roof system under various loading conditions. This will give us a baseline on the structural capacity of the current system and allow for us to explore options for supporting the cupola structure. It is possible that some elements of the current roof system may be overstressed or at least poorly performing. We recommend that a structural analysis of the roof framing be undertaken as soon as possible to help determine what the state of stress is in these members.

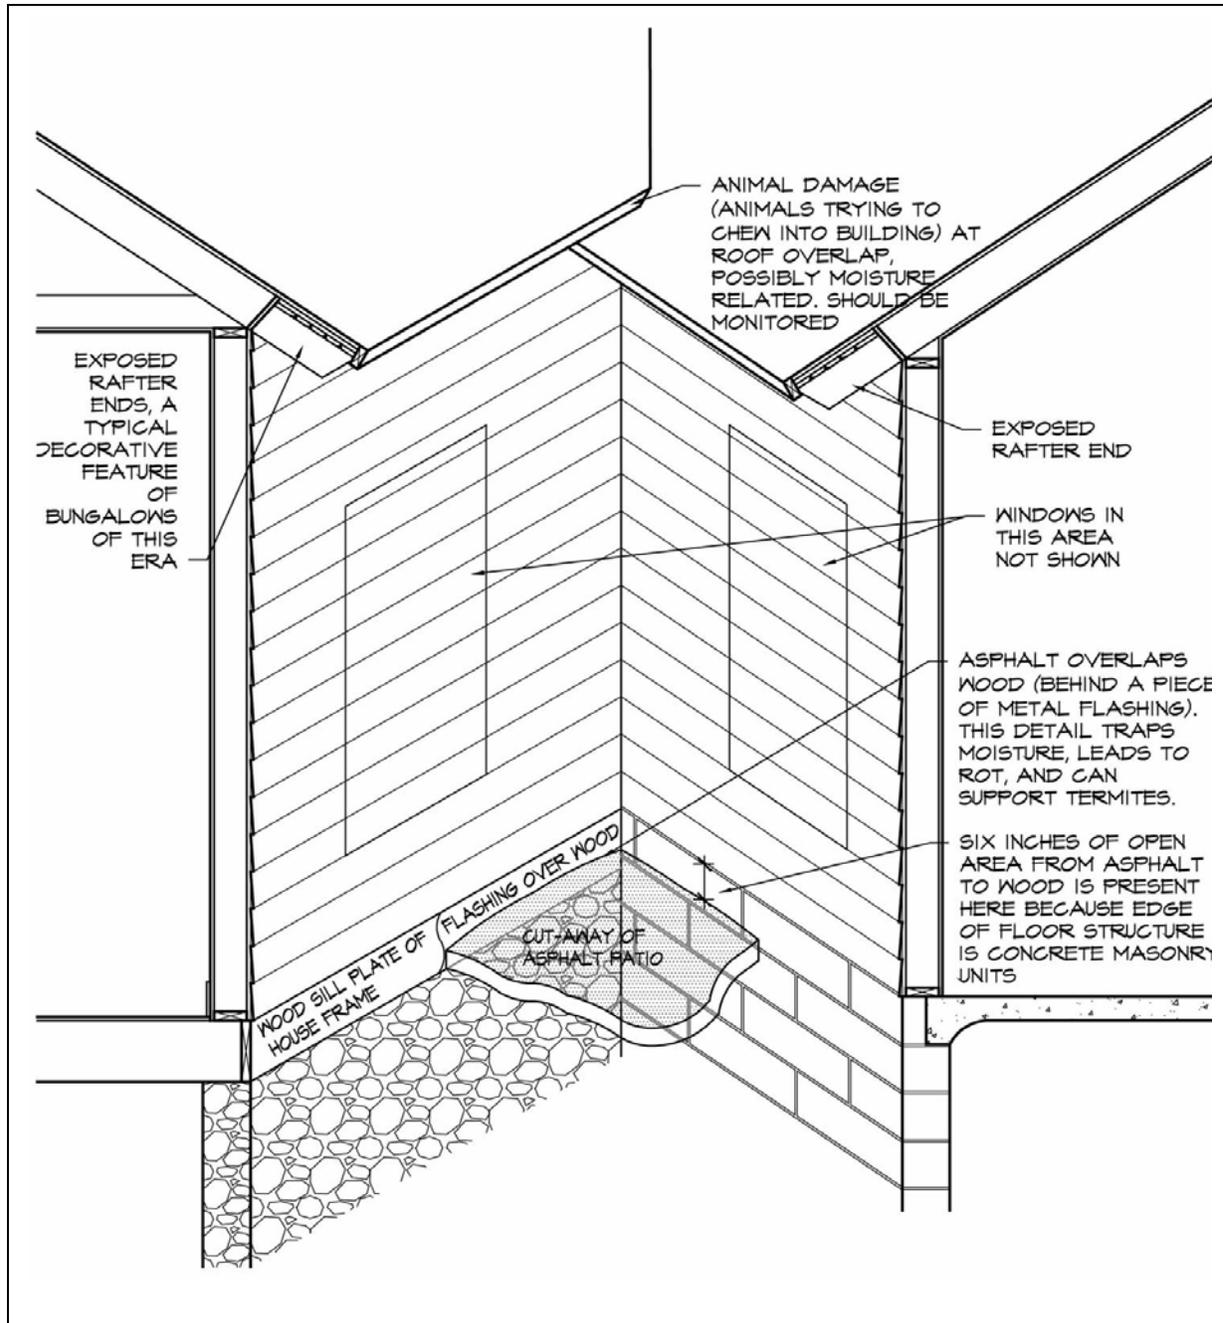
Wall Drawing

- Site drainage problems: The roof has no gutters and drains directly to grade, which is problematic given the constrained site and the amount of hard surface touching the building. At the east, the roof drains directly onto HVAC equipment. At the west addition, the roof drains directly onto asphalt that has no provision for site drainage, causing biological growth at the building foundation. At the rear (north) elevation of the original building, water falling from the roof has eroded soil at the foundation.

- The asphalt patio at the back of the addition is covering the edge of the wood sill of the northwest corner of the original building. The error was caused by locating the asphalt with respect to the concrete-floored addition, where the wood starts about eight inches higher.

- Leaks in basement: There is a gap at the basement door at the main (south) façade.
- Wood rot: There is wood rot in several areas, typically in areas of recent repairs. There is rot at the front door sill under the threshold. This looks like a recent repair and indicates rapid deterioration. At the west addition, the base areas of the door jambs are rotted at both north and south doorways.

- Paint failure: Paint at the window trim is beginning to fail overall. At the west addition, the wood at the door sill and sidelights is badly weathered and is no longer protected by paint. On the east, the main door threshold has no paint. Wood trim at the roof eave and all wood doors have failing paint overall.

- Concrete and stone cracking: Metal handrails at the east entrance are corroding and cracking the slate treads. The cast-in-place concrete base has cracking at cold joint locations with efflorescence, indicating that water is moving through the steps.

- Lack of mortar: Granite wall to the west of the Gardener's Cottage has missing mortar overall. The wall needs to be repointed to assure stability.

- Maintain paint at wood trim. Use good quality paint [MPI—Master Painting Institute, Premium Grade Paint] and proper preparation techniques.
- Maintain paint at metal handrails to prevent corrosion and damage to masonry foundations.
- Use rot-resistant wood types for exterior wood trim repairs.

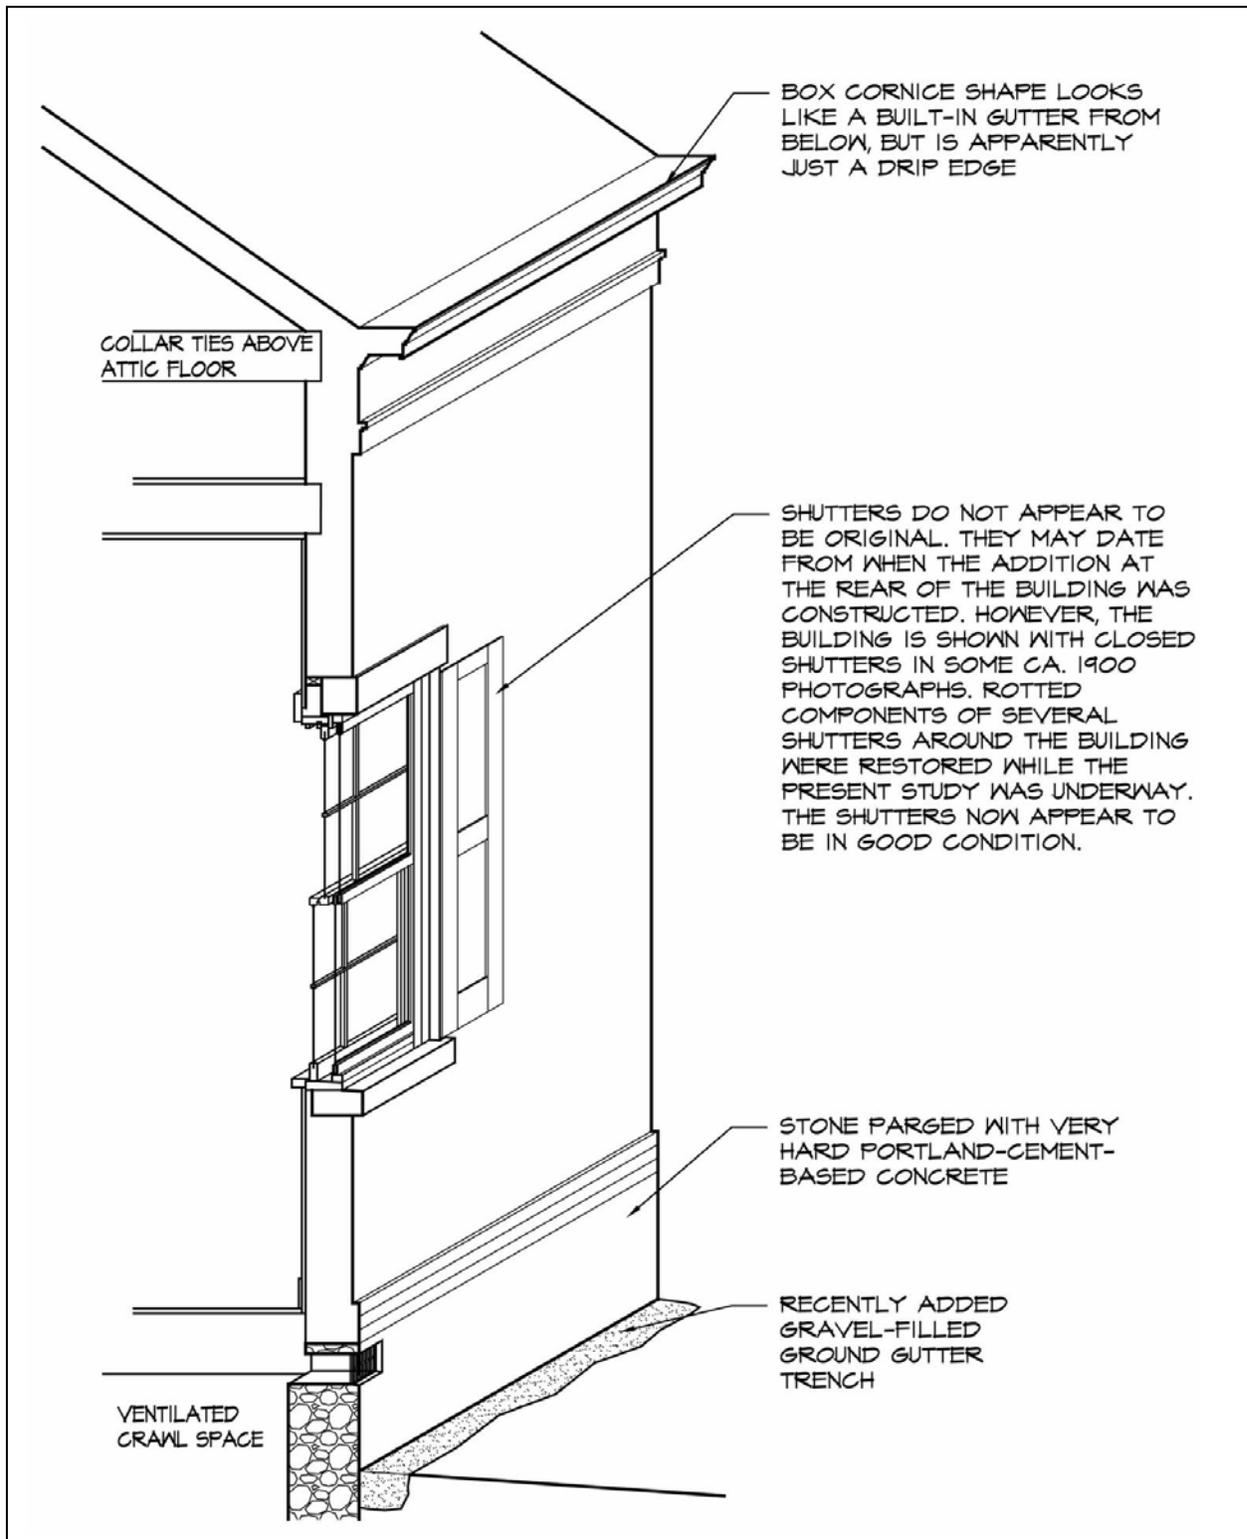
Wall Drawing

- Corrosion of louver vents: At least one louvered basement vent in the modern rear addition is corroding. At least one crawl space vent cover in the main part of the building is broken beyond repair.

- Basement ventilation grates in the main part of the building need to be repaired, replaced, or redesigned. It may be possible to retain the design of the cast grates (the smaller openings) if an intact one can be removed to be used as a pattern.
- The electrical systems should be upgraded, and the HVAC system should be replaced with equipment that is not visually intrusive and meets the *Secretary of Interiors Standards*.

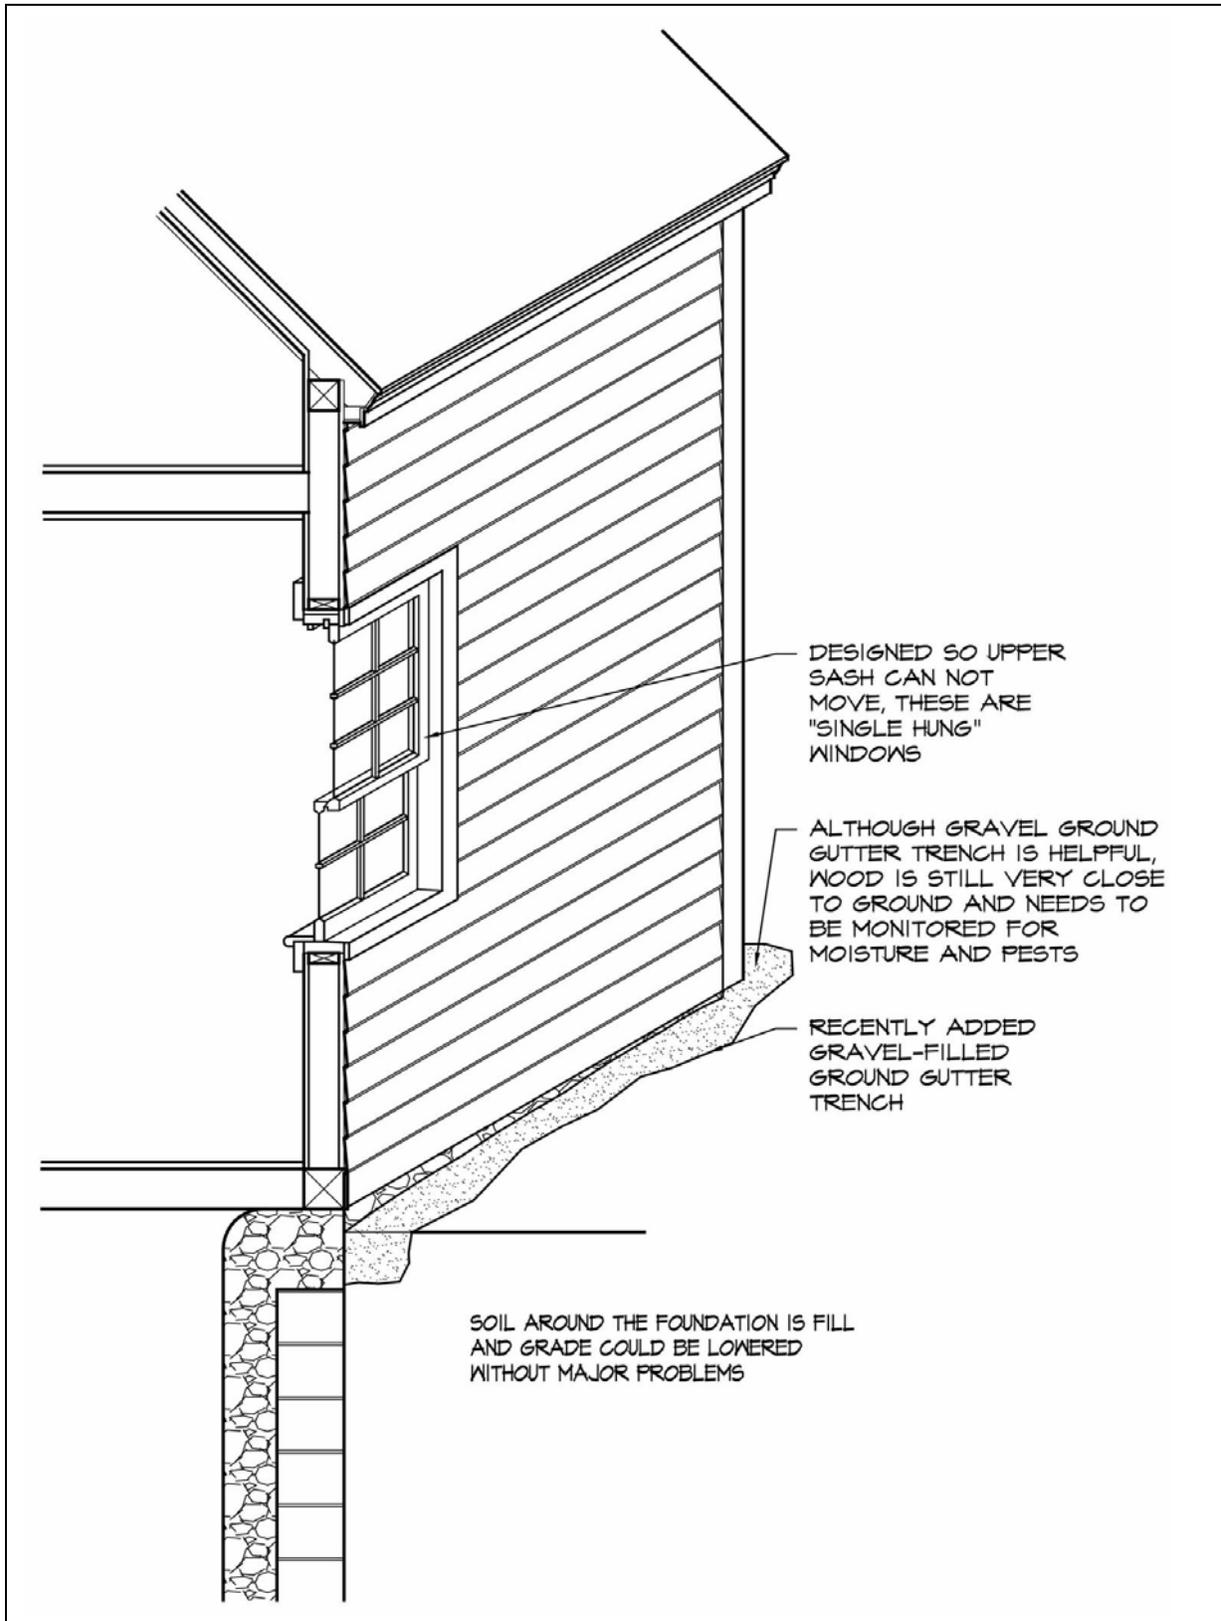
Wall Drawing

Several years ago, the sill plate and some parts of adjoining joists were found to be deteriorated from wood rot at the Governor Fitch Law Office building in the area around the building's main entrance. A chemical consolidant process was used to restore the structural capacity of the damaged wood joists. This was a good solution at the time, as the consolidants make the wood hard and restore some of its structural capacities. However, use of consolidants in situations where the source of the moisture is not stopped is likely to lead to more rotting. In its natural state, wood like most organic building materials overcomes episodes of moisture by allowing the water to migrate through the material at approximately the same rate that the water is evaporating and the material is returning to its dry state. A chemical change in the material stops the migration at the edge of the repair, creating the possibility that the damage will advance into the parts of the original material that were not damaged before the repair. Therefore, it is critical

- The roof needs to be replaced.
- A rotted section of flooring and associated materials at the entrance threshold needs to be repaired.

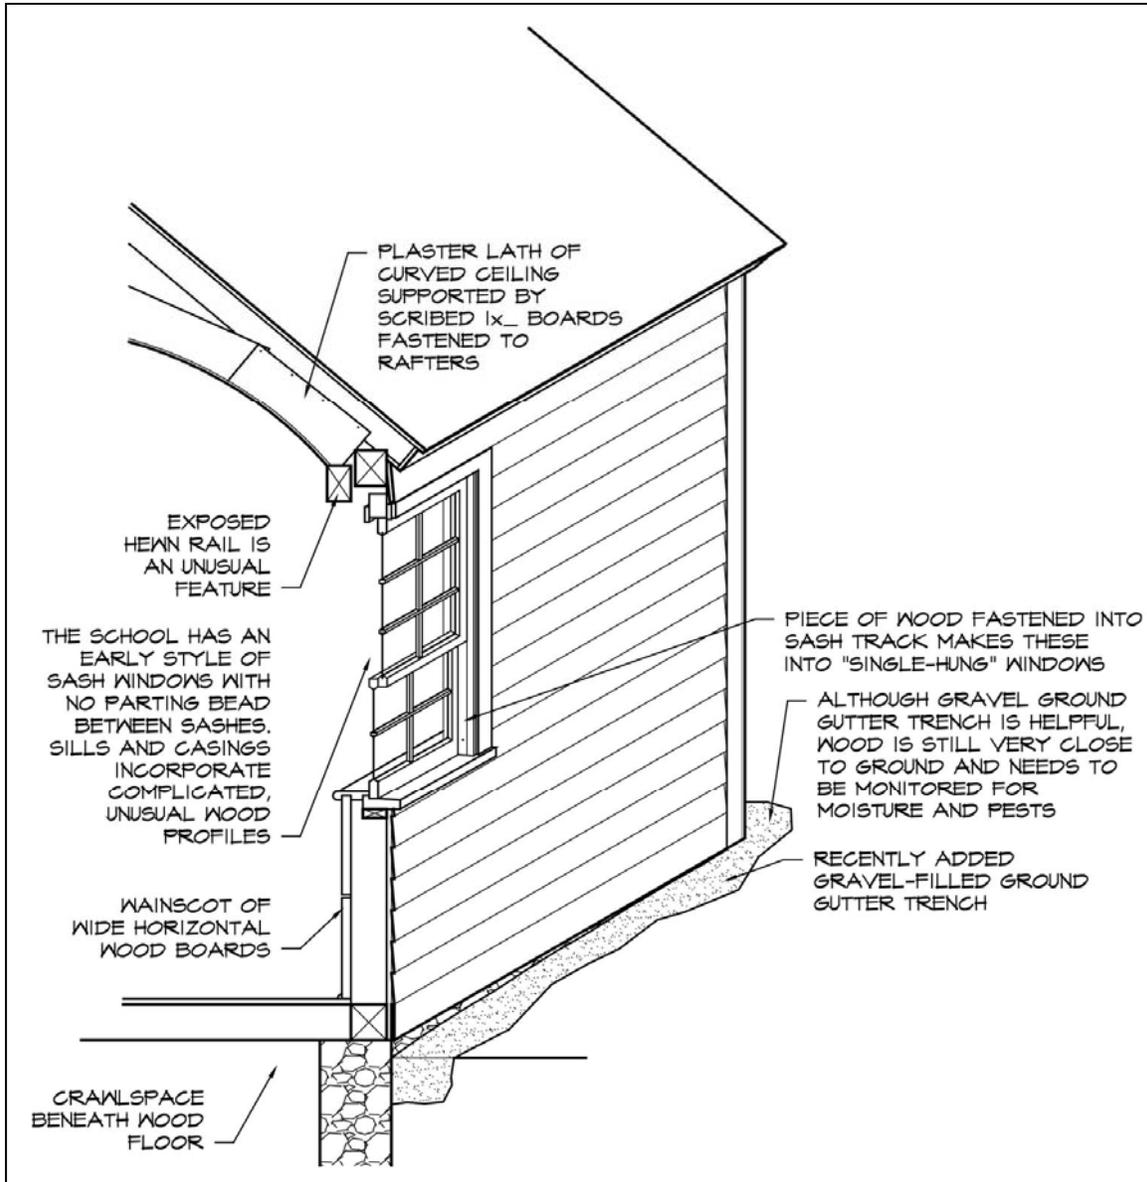
Wall Drawing

The bottom edges of the exterior wood components of the building that lie closest to the ground are moist and visibly rotting. This wood will have to be replaced.

- Inappropriate foundation height: The wood frame building sits almost at grade, promoting rot at lower portions of the wood frame and siding. The recently installed “drip strip” gravel aprons may improve site drainage, but they need to be monitored to make certain.
- Poor site drainage: There is evidence of poor site drainage to the east and southeast of the building where there are large areas of moss. There is a small knoll to the east and southeast of the site, which contains water in this area.
- Wood rot: The wood is rotting at the main north entrance at the threshold and the lower three inches of the vertical board door. There is also wood rot at the northeast and southwest corners at the foundation. Unprimed edges of the wood siding at windows are accelerating rot at the end grain of bead boards.
- Paint failure: There is minor paint failure at the wood siding.

material is likely to channel moisture into the wood and camouflage insects and other pests that may be working their way into the moist wood. In the long run, this may evolve into a larger problem. A better solution would be to lower the grade around most of the perimeter of the building so that the distance between soil and wood is at least six inches and also dig a trench approximately six inches deep at the edges of the building, provide a drainage system within the trench to carry water away from the building, and fill the trench with gravel. Ideally, the gravel would be brown in color, similar to the color of dry exposed soil in the area.

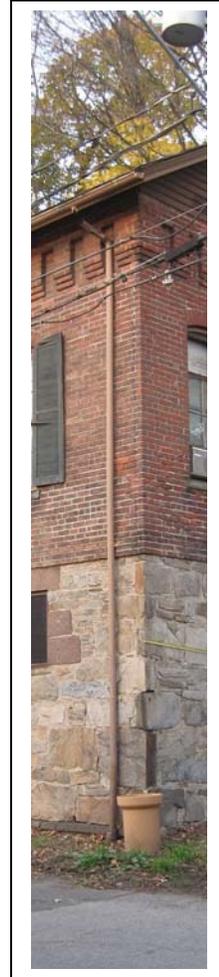
The stone construction makes the bottom level of the building very different from the brick upper story. When the original lock-up was built, it was designed for a simple set of circumstances, to contain a small number of people who had committed or been accused of committing crimes. It was typical to use masonry walls composed of large pieces of quarried stone and fieldstone to build small jails of this type. Notably, each cell within the jail also has brick or stone side walls and some appear to have stone slab ceilings. Because masonry was the construction material, and because the possibility of prisoners escaping through the ceilings of the cells had been addressed, the sloped site represented an opportunity to bank the building into the hillside, making escape through the back wall even more difficult. This created a building that was more like a basement on one side, even though about two thirds of the perimeter walls remained completely exposed. The stone, therefore, serves a very different function on the banked side, where it is holding back a hillside, than it does on the three exposed sides.

Below-grade construction places forces on masonry walls that can lead to problems. Not only are the walls subjected to moisture, which can destroy mortar and even attack the stone, but moist soil on the uphill side of a banked building tends to move downhill, placing horizontal forces on the walls. The Old Jail site is an extreme example of this in one sense: the building was built at the base of a long, steep hillside, and the slope sends a substantial amount of water toward the building. The vegetation on the hillside, while helping to hold the soil in place, also keeps the sloped area shaded and covered with organic material that retains water.

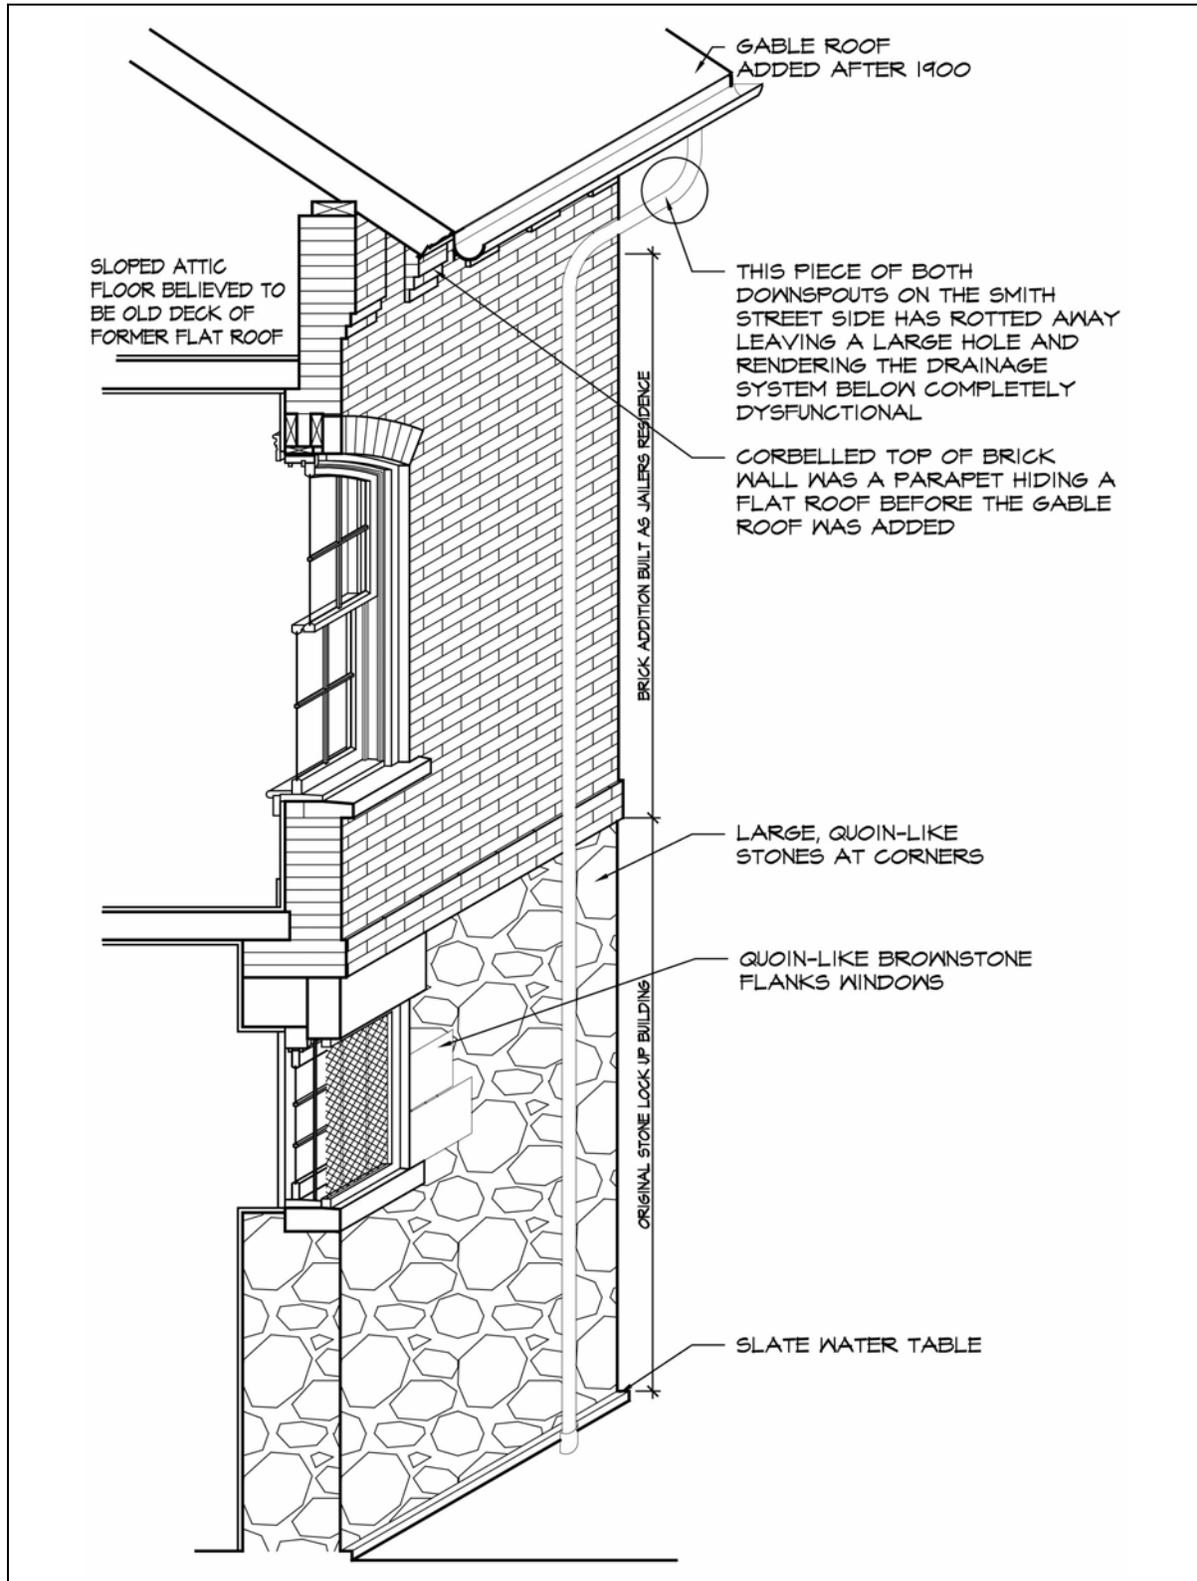
Wall Drawing

- Cracking at masonry foundation: There is cracking through the foundation masonry under the southeast basement window.
- Mortar failure: The brick and foundation masonry exhibit loss of pointing mortar.
- Paint failure on wood: The wood siding at the southeast gable end has failing paint. Paint at the windows is failing overall.
- Deterioration of louvered shutters: The wood louvered shutters are deteriorating and falling apart.
- Roof shingle repairs: The wood shingles are loose on the southwest side of the roof.
- Lack of downspouts: The two round corrugated downspouts at the southwest are no longer connected to the gutter. Water drains directly from the gutter opening to the ground.

- Check all floor framing for structural adequacy and joinery, repair as needed, and assure that all openings are properly framed with headers, etc.
- Investigate cracking at southeast foundation.
- Rebuild louvered wood shutters.
- Re-point in select areas after analyzing the original pointing mortar in order to characterize the original binder and sand and guide replication mortar selection. Produce site mockups to refine the final mortar mix.
- Paint all exterior wood trim.
- Investigate the roof shingles and repair as needed.
- Provide a second means of egress from apartments as soon as possible (this might include removing or altering the fixed iron grates on the east elevation windows so it would be possible to exit from windows in the case of a fire).

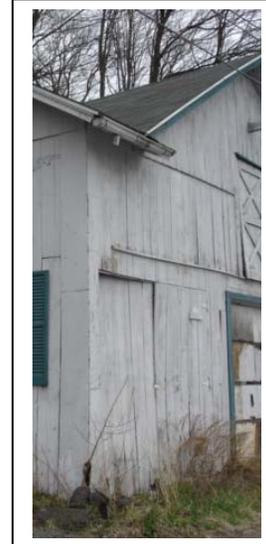
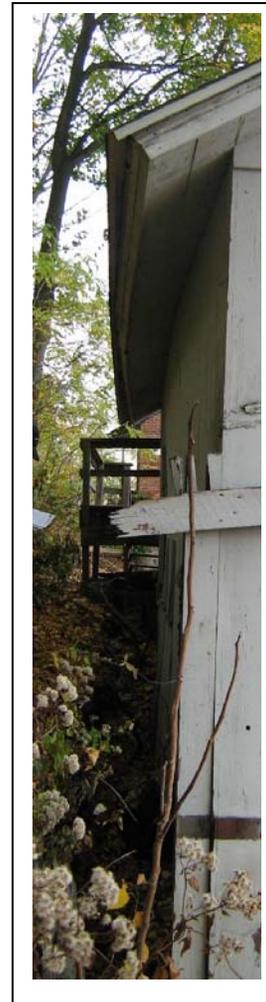
Alterations that have occurred over the years have changed the character and design of the barn, and it is consequently difficult to know the building's original characteristics. Beneath the vertical "barn siding" boards, the walls appear to be constructed of light wood frame. Much of the framing is hidden behind non-historic interior finishes, but the visible framing is the kind of light-weight materials usually used in houses rather than in typical barn construction. The building was not designed to be heated, and therefore, it may have always been intended as a storage space as well as a stable. The interior wall surface materials concealing much of the framing appear to consist of plywood

and other similar sheet goods installed for expedience without concern for consistency (not all wall areas were visible at the time of the site visit because the barn was filled with storage, and some areas were blocked by falling ceiling materials and other obstacles). Generally, they have remained unpainted. Heavy wire “cloth” was also used in a number of places. As the building has fallen into disrepair, many layered remodeling materials have begun to come loose and disheveled. As the building declines and is attacked by moisture and pests, some of the layered modern materials may be more conducive to retaining moisture than the older materials are.

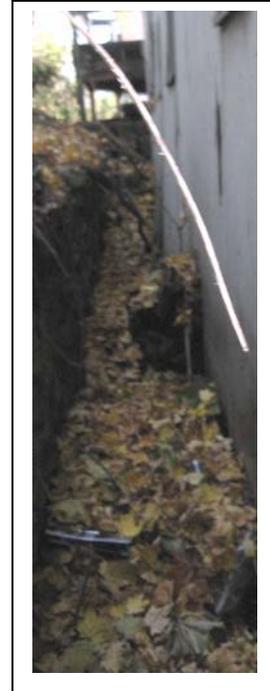
Infiltration of moisture from the bottom of the building and at exposed horizontal surfaces, such as the wood deck, may have contributed to the deterioration of the barn. The building is in poor, even precarious condition, but the structure has been reinforced by a steel I-beam and round steel columns that were added at the center of the interior. The I-beam and columns support the original summer beam on which the second story floor boards rest. In length, each of the joists is only a little more than half the depth of the building. The joists are lapped over the summer beam, which runs from side to side below the ridge of the roof. The summer beam was originally supported on wood columns, as evidenced by ghosting in the paint at the bottom surface of the beam. The original columns were apparently removed, or replaced by steel, in order to reconfigure the barn as a three-vehicle garage when the center garage door was added. It is also possible that the replacement was because they had rotted or failed structurally.

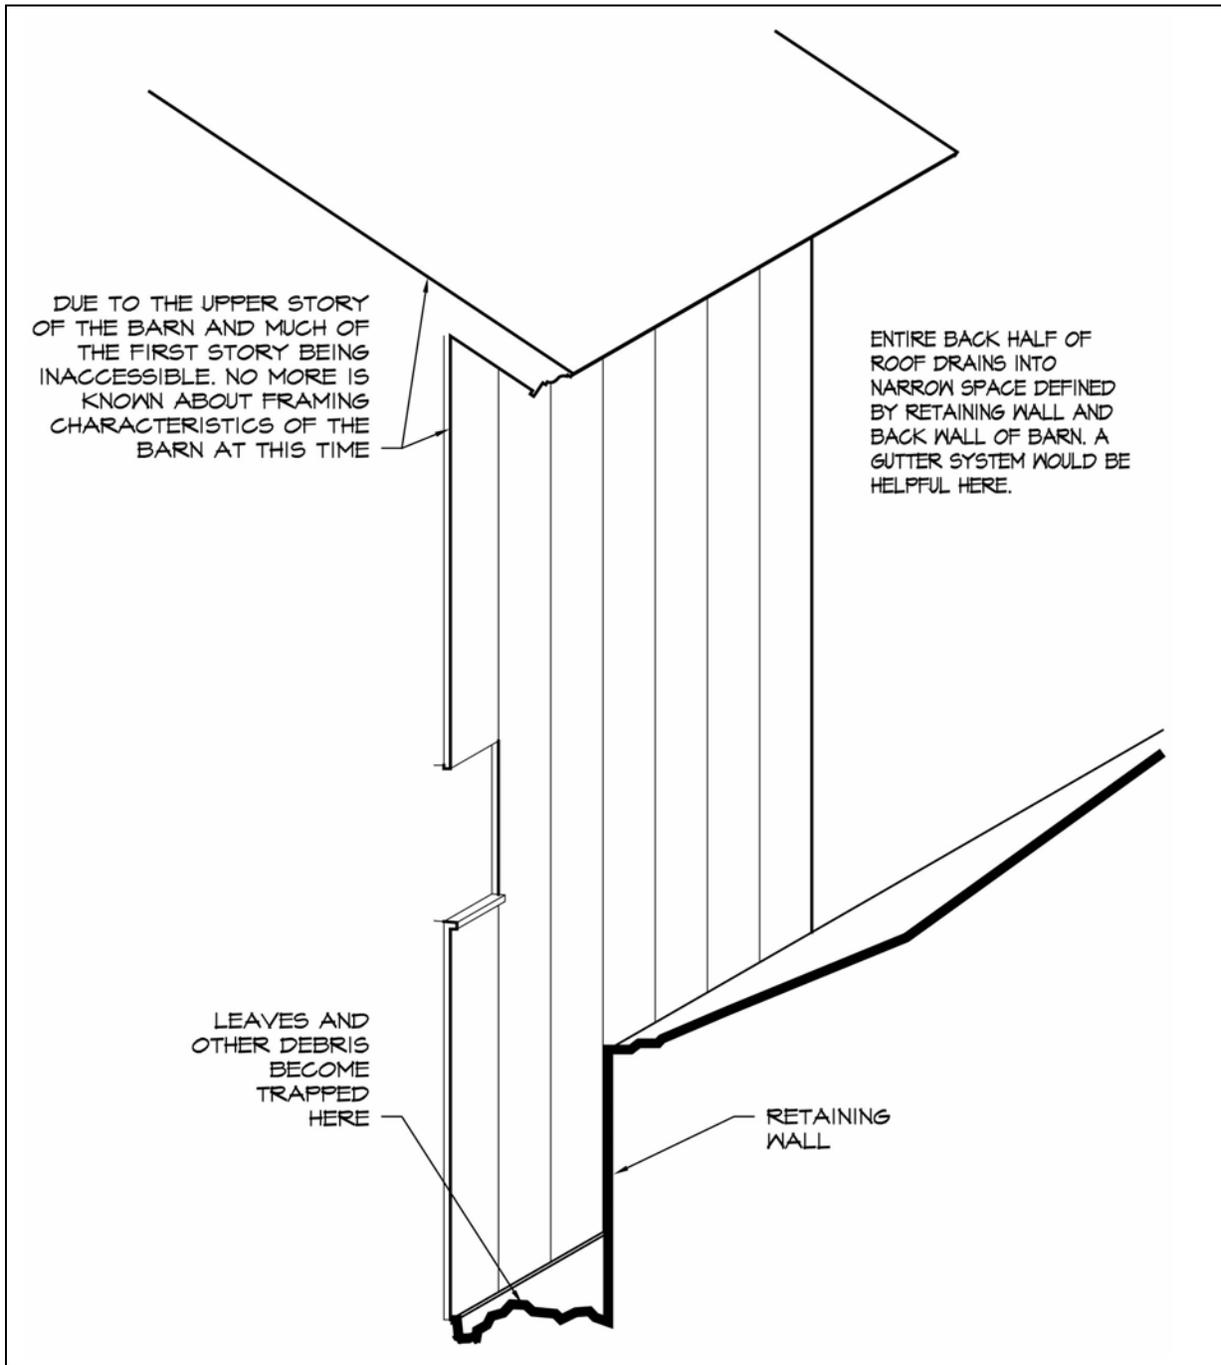
Wall Drawing

- Poor site drainage: The steep slope behind the barn stops at a narrow walkway to the rear of the barn. This area appears to be chronically damp.
- Inappropriate foundation/soil height: The vertical wood siding is in contact with the ground which is promoting rot at the bottom of the wood siding.
- Unsafe conditions: The cinder block addition and the deck structure above it at the building's southeast corner are in unsafe condition and should be demolished.
- Clogged gutters: The gutters at the southwest elevation are full of debris and the rain leaders are missing.
